# IN-SITU TEST OF SCHOOL BUILDING STRUCTURE IN TAIWAN

## ABSTRACT

The 1999 Chi-Chi earthquake revealed the poor performance of the RC school buildings in Taiwan. It also indicates an urgent need of seismic evaluation and retrofit for the remaining schools. In order to realize the behavior of a typical school building subjected to lateral load, an in-situ test for an existing 2-story school building was carried out. Two experiments were conducted: static push over test to identify the strength, stiffness and toughness of the building, and vertical load test to study the vertical load carrying mechanism after part of members failed. In the static push over test, a 6-classroom building constructed in 1964 was cut in the middle where jack was set for monotonic loading along the longer axis of building. One half of this building was reinforced by steel bracings to provide reaction support, while the other half was pushed to failure. The vertical load test employed only one of the classrooms. Inner columns of 1F of the classroom were cut off in the middle to simulate that they are failed prior due to the short-column effect. The remaining frames with thick brick in-filled walls as part

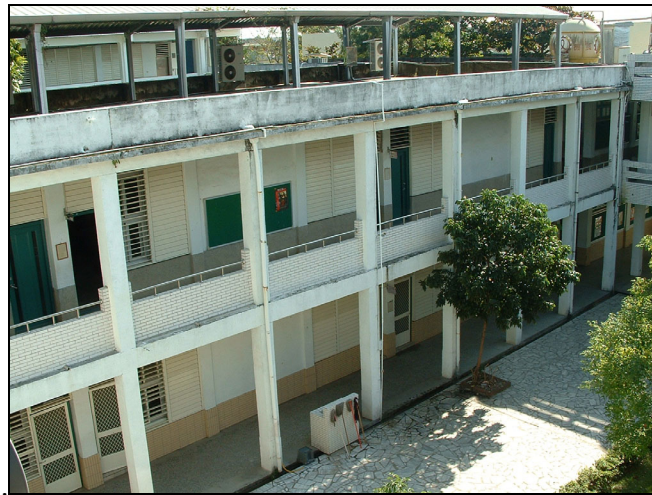
Fig. 2 Pictures of the subject building

(RC), but the partitions and windowsills are made of 1-brick-thick brick walls. The building had no visible damage before the test, as shown in Fig. 2.

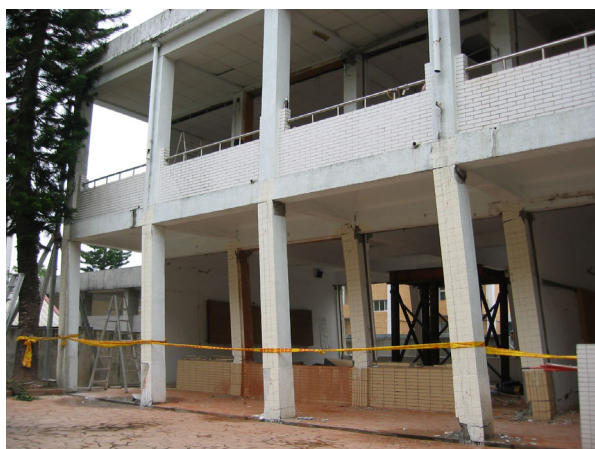
Fig. 7 Specimen: after the test

Fig. 7 shows the final scene of the specimen at a roof drift ratio of about 4%. However, most deformation happened at 1F, while the 2F seemed remain undamaged, so the drift ratio at 1F was actually nearly 8%. Fig. 8 shows the push over curve of the specimen. The maximum base shear  $P$  is 2915kN when the roof displacement  $\Delta_2$  reached 150mm. Some indentations showed when the actuators were hold for recording damages, however the shape of curve is still smooth and shows very good ductility.

As shown in Fig. 7, the normal columns at A-frame obviously failed by flexural bending and concrete at the compressive side crushed. Other normal columns in B-frame showed the same failure pattern. Otherwise, the short columns mostly failed by both bending and shear. Both horizontal and diagonal cracks showed in these columns' ends, as shown in Fig. 9. The diagonal cracks caused by shear stress show that the short-column effect did happened. While all of the columns had failed, the beams and slab still remained almost undamaged. This phenomenon, so-called strong-beam-weak-column, was also found in those school buildings damaged by the Chi-Chi earthquake.

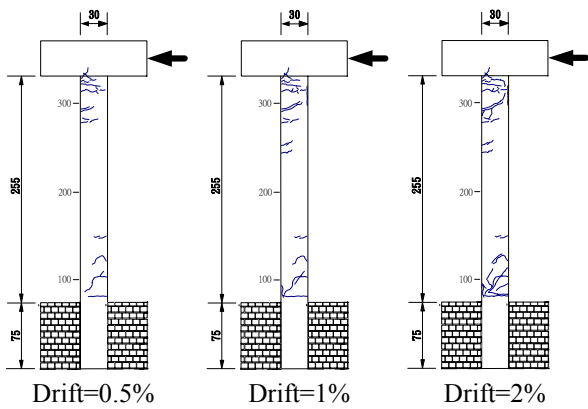
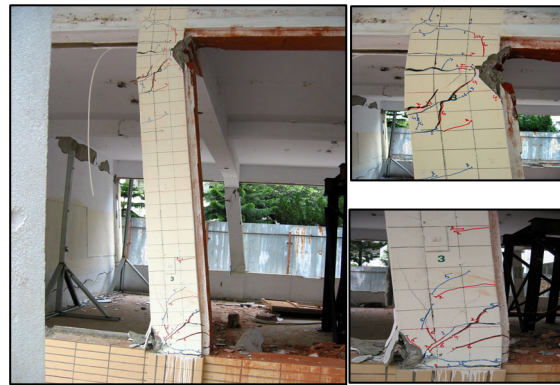
Fig. 9 Column failed by bending-shear

(a) Crack development

(b) Picture of final stage

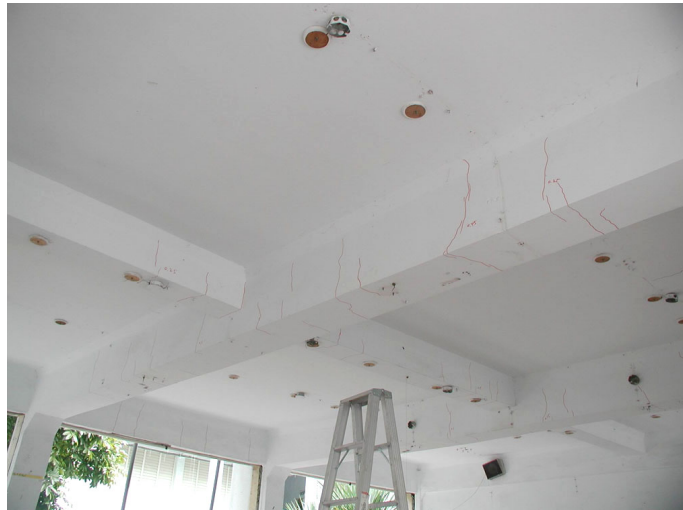
Fig. 11 Cracked beams after the vertical load test

It took two days to fill the tanks, but even though the two tanks were both filled, beams and slab of 1F were only slight cracked, as shown in Fig. 11. Most cracks closed after unloaded; apparently the steels in them still remained elastic. Fig. 12 shows the progress of loading and sag of 1F slab. Because of errors in water line reading, the curve is not very smooth. But it's clear that loading at 2F top has less influence on the sag of 1F slab than loading at 1F top does, probably due to the participation of 2F beams and columns. The specimen sustained 105 tons of extra loads, which are about 1.5 times of its self-weight. The test result shows that brick partition walls may be a useful support against vertical failure.

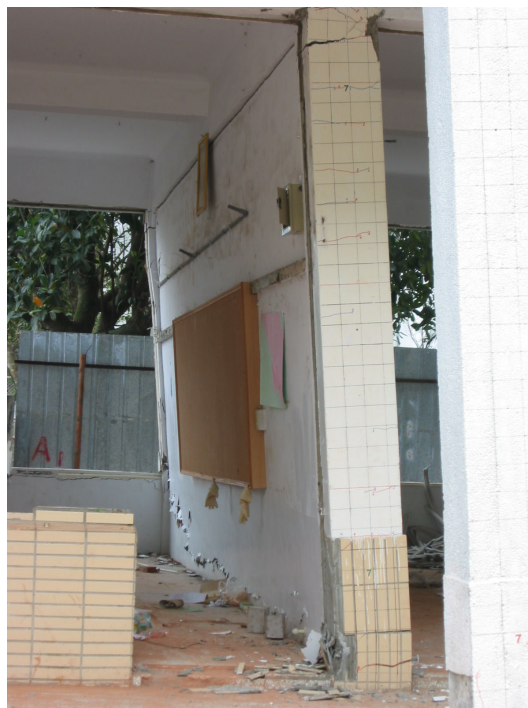
Fig. 15 Brick partition wall deflected in out-of-plane direction

Fig. 14 shows the comparison between test and analytical result. The analytical prediction about failure mode of columns corresponds with the test result. But the analytical push over curve obviously underestimates the strength and stiffness of the specimen. A possible reason of the error is the out-of-plane contribution by the partition brick walls. As shown in Fig. 15, the brick partition walls connected to the columns tightly and seemed provide some out-of-plane strength. But the out-of-plane behavior of brick wall still remains to be studied.
