# IN-SITU TEST OF SCHOOL BUILDING STRUCTURE IN TAIWAN

## ABSTRACT

The 1999 Chi-Chi earthquake revealed the poor performance of the RC school buildings in Taiwan. It also indicates an urgent need of seismic evaluation and retrofit for the remaining schools. In order to realize the behavior of a typical school building subjected to lateral load, an in-situ test for an existing 2-story school building was carried out. Two experiments were conducted: static push over test to identify the strength, stiffness and toughness of the building, and vertical load test to study the vertical load carrying mechanism after part of members failed. In the static push over test, a 6-classroom building constructed in 1964 was cut in the middle where jack was set for monotonic loading along the longer axis of building. One half of this building was reinforced by steel bracings to provide reaction support, while the other half was pushed to failure. The vertical load test employed only one of the classrooms. Inner columns of 1F of the classroom were cut off in the middle to simulate that they are failed prior due to the short-column effect. The remaining frames with thick brick in-filled walls as part

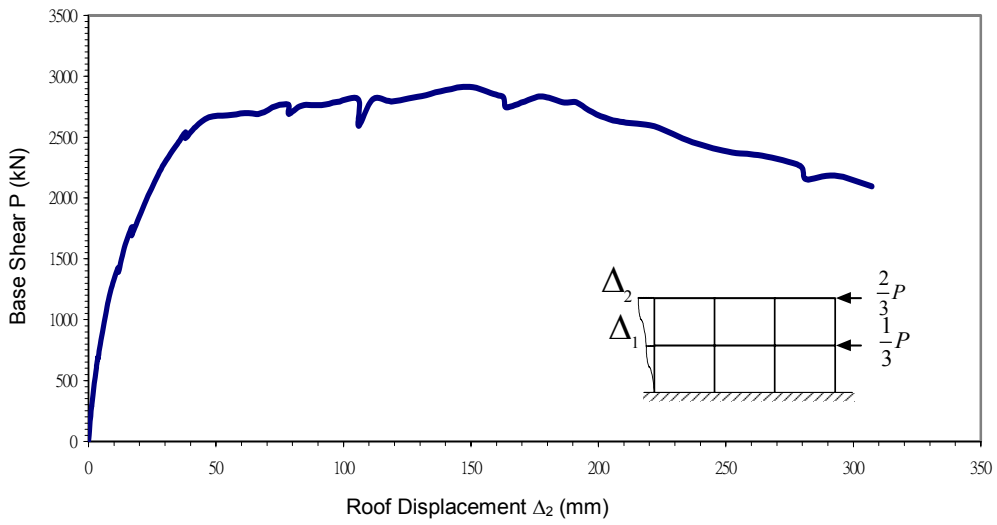
Fig. 8 Push over curve of the specimen

Fig. 7 shows the final scene of the specimen at a roof drift ratio of about 4%. However, most deformation happened at 1F, while the 2F seemed remain undamaged, so the drift ratio at 1F was actually nearly 8%. Fig. 8 shows the push over curve of the specimen. The maximum base shear  $P$  is 2915kN when the roof displacement  $\Delta_2$  reached 150mm. Some indentations showed when the actuators were hold for recording damages, however the shape of curve is still smooth and shows very good ductility.

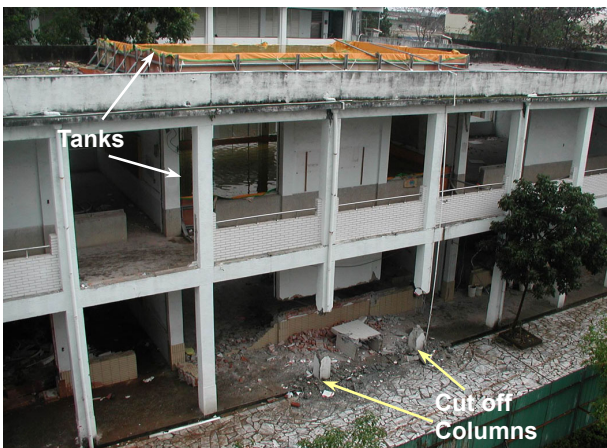
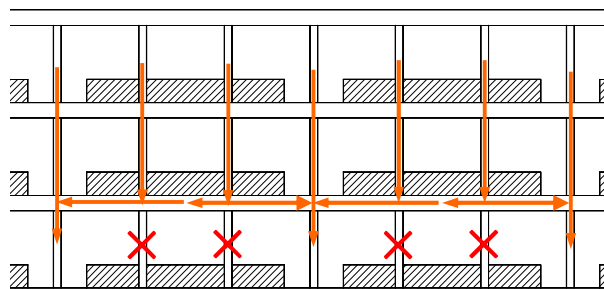
Fig. 10 Vertical load test

Objective of vertical load test is to know that if a school building still has vertical sustainability after the prior failure of short columns. So as shown in Fig. 10(a), a classroom of the south half of the subject building was chosen to be the specimen. Six inner columns were cut off in the middle, and the other 6 ones with the partitions were left to simulate the situation that part of columns has been failed by short-column effect. The vertical load is supposed to be carried by the beams and passed on to the remaining partition walls and columns, as shown in Fig. 10(b).

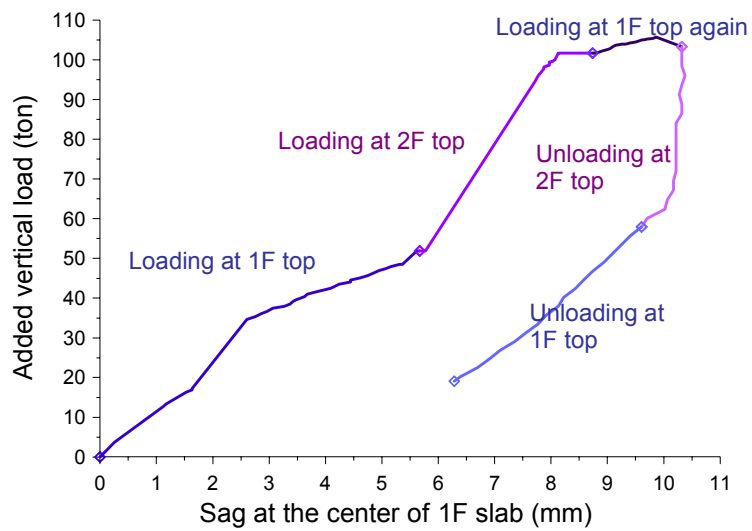
Fig. 12 Relationship between vertical loading and sag at the center of 1F slab

It took two days to fill the tanks, but even though the two tanks were both filled, beams and slab of 1F were only slight cracked, as shown in Fig. 11. Most cracks closed after unloaded; apparently the steels in them still remained elastic. Fig. 12 shows the progress of loading and sag of 1F slab. Because of errors in water line reading, the curve is not very smooth. But it's clear that loading at 2F top has less influence on the sag of 1F slab than loading at 1F top does, probably due to the participation of 2F beams and columns. The specimen sustained 105 tons of extra loads, which are about 1.5 times of its self-weight. The test result shows that brick partition walls may be a useful support against vertical failure.

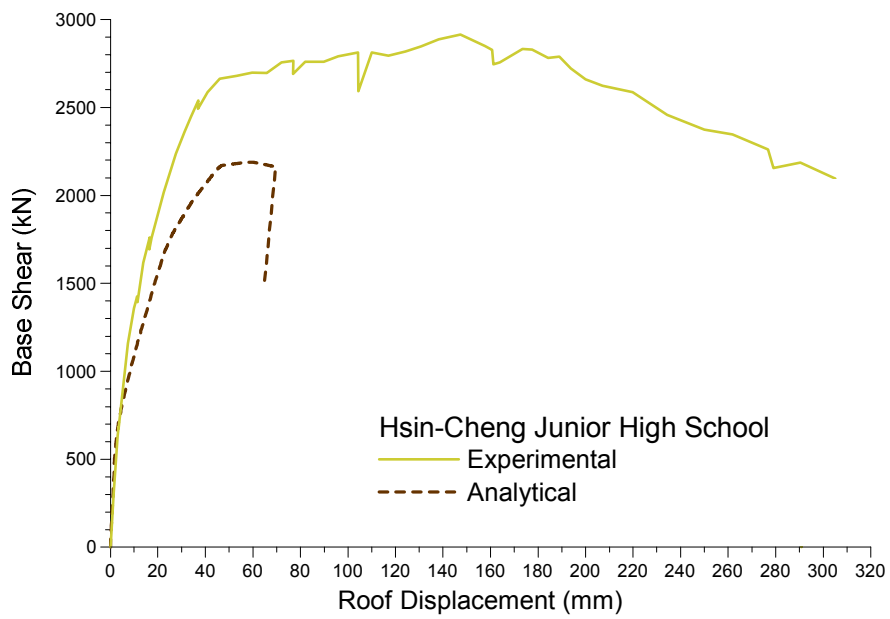
Fig. 14 Comparison of test and analytical push over curve

Fig. 14 shows the comparison between test and analytical result. The analytical prediction about failure mode of columns corresponds with the test result. But the analytical push over curve obviously underestimates the strength and stiffness of the specimen. A possible reason of the error is the out-of-plane contribution by the partition brick walls. As shown in Fig. 15, the brick partition walls connected to the columns tightly and seemed provide some out-of-plane strength. But the out-of-plane behavior of brick wall still remains to be studied.
